VAN'S AIRCRAFT, INC.

SERVICE BULLETIN NUMBER: 04-3-1

APPLICATION: Electric flap drive motors.

SUBJECT: Multiple holes in attach lug.

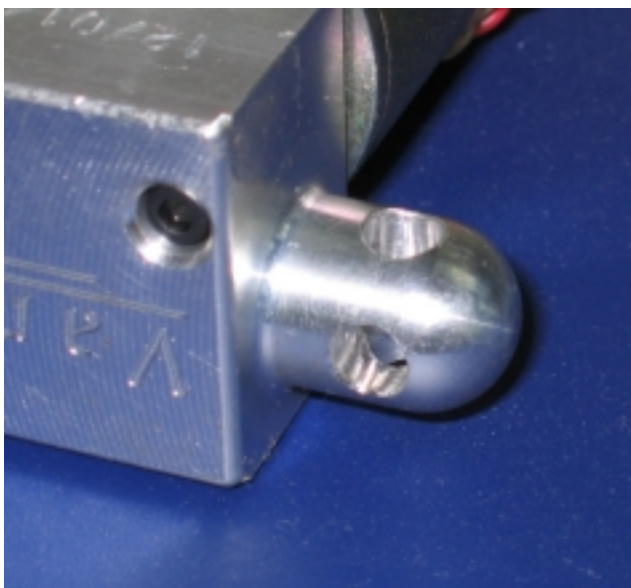
The manufacturer of the motor/drive assembly used in all RV electric flap installations is recalling some flap motor/flap drive assemblies. The actuator arms of these components have been drilled with two holes at right angles, instead of the intended single hole (see illustration).

Although no service difficulties arising from this aspect of the electric flap installation have ever been reported to Van's Aircraft, Inc., we are requesting the return of all such electric flap motor/drive assemblies.
